FACILITY CONDITION ASSESSMENT

MIAMI TOWNSHIP MUNICIPAL FACILITIES
6101 MEIJER DRIVE, MILFORD, OHIO
American Structurepoint Project No. 202500629
May 20, 2025

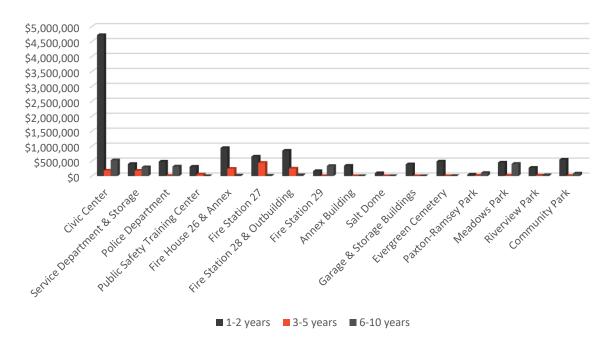
The following table displays the current and forecasted needs by facility system and component classifications within the various priorities for the five-year evaluation term.

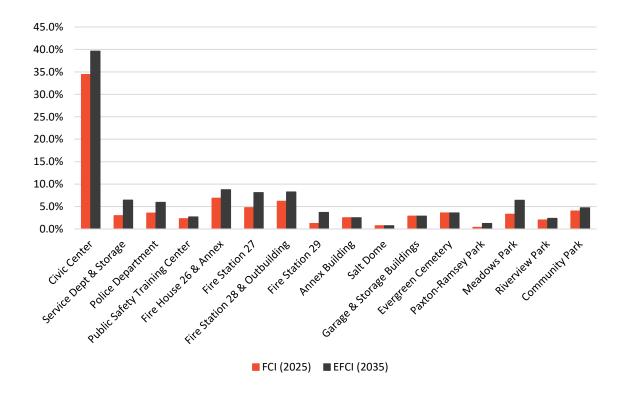
The Assessment Team estimated the costs of the identified deficiencies, deferred maintenance, identified code violations, and anticipated capital needs to calculate a Facility Condition Index (FCI) for the facilities included in this assessment. The following table displays the facility's current FCI ranking and provides a 10-year Extended FCI (EFCI) that would reflect the condition of the facility if no capital investments were considered during the next 10 years.
